**SITE ASSESSMENT/REMOVAL ACTION REPORT
FOR
DC FRANCHE METAL COATINGS
CHICAGO, COOK COUNTY, ILLINOIS
TDD: T05-9504-015
PAN: EIL0884VAA**

June 5, 1995

**Prepared for:
UNITED STATES ENVIRONMENTAL PROTECTION AGENCY
EMERGENCY AND ENFORCEMENT RESPONSE BRANCH
77 West Jackson Boulevard
Chicago, Illinois 60604**

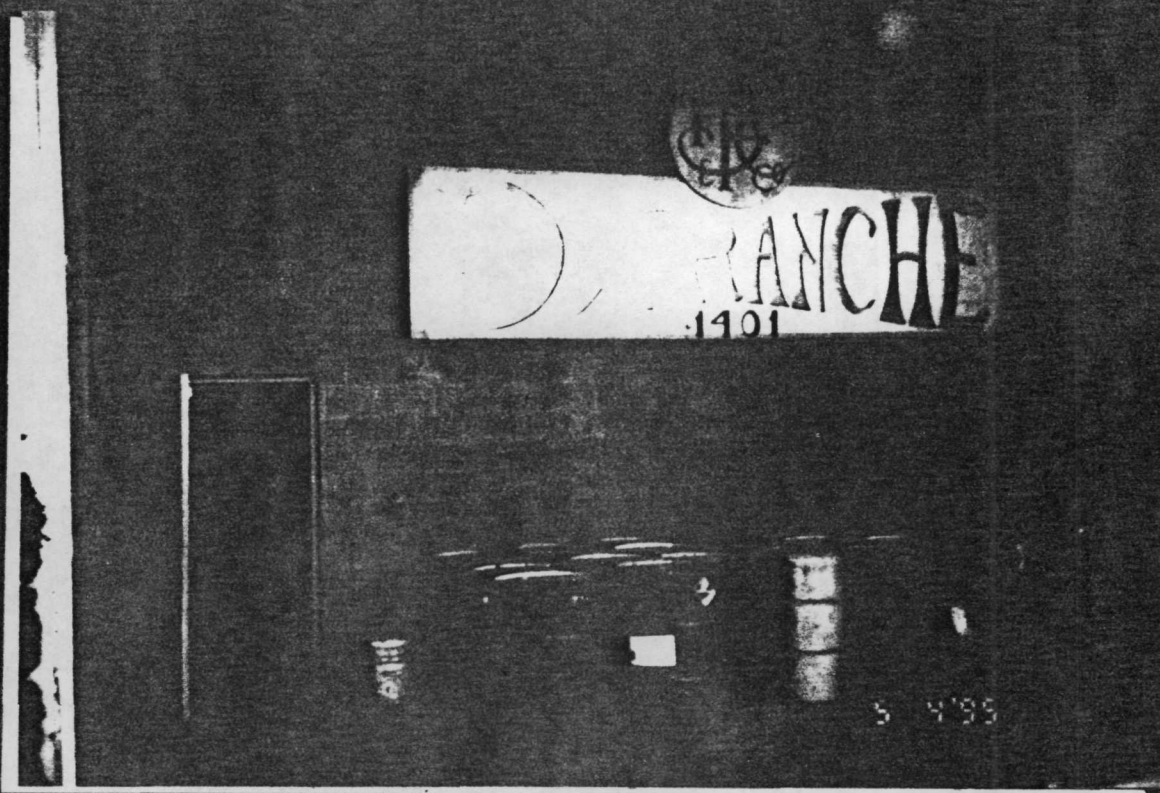
CAMERA: FUJI DISCOVERY PLUS 80
FILM: KODAK GOLD 100 ASA, 24 EXPOSURE
SUBJECT: VIEW OF DRUMS IN LOADING DOCK AREA.

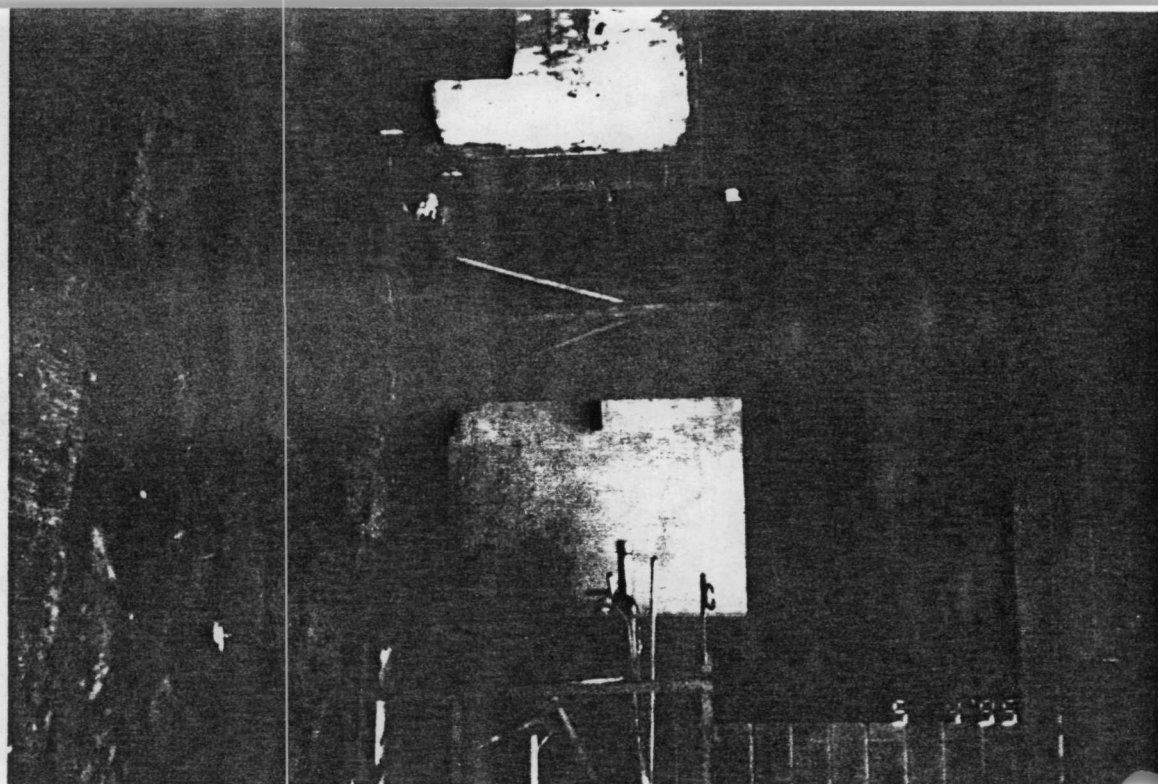
CAMERA: FUJI DISCOVERY PLUS 80
 FILM: KODAK GOLD 100 ASA, 24 EXPOSURE
 SUBJECT: VIEW OF DRUMS STACKED THREE HIGH IN BAY AREAS WEST OF LOADING DOCK.

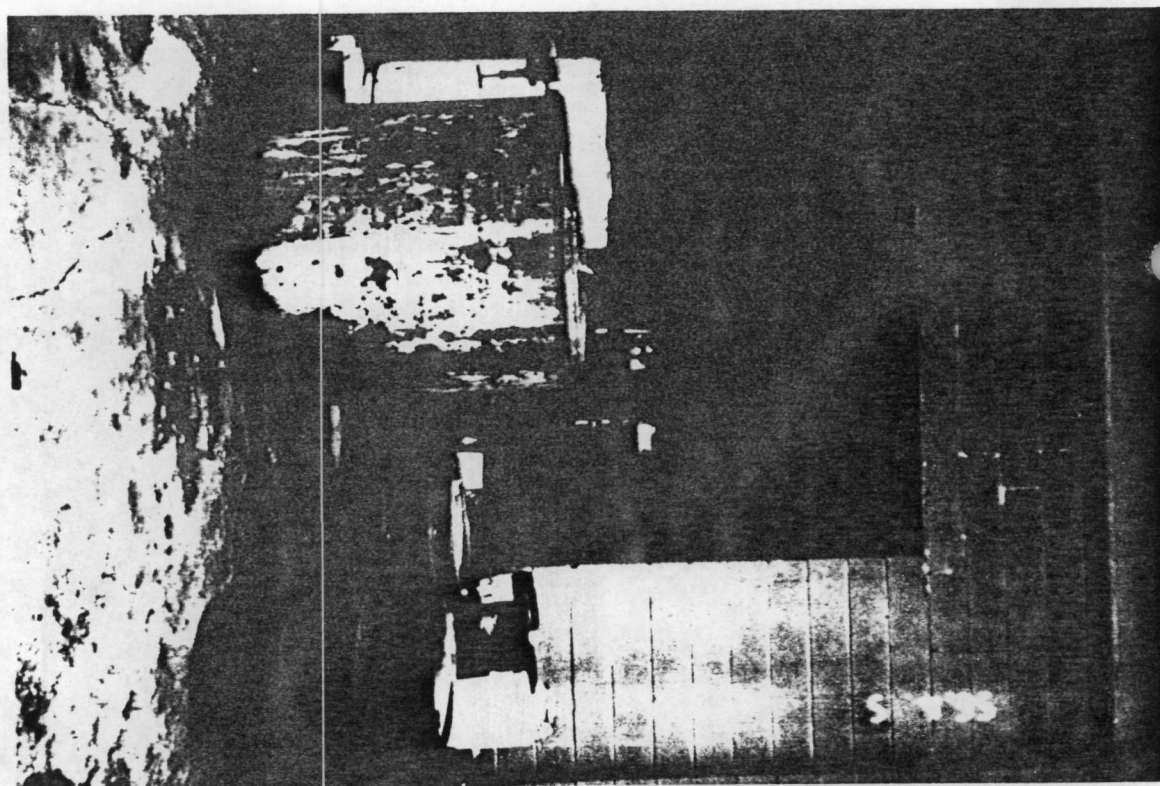
CAMERA: FUJI DISCOVERY PLUS 80
 FILM: KODAK GOLD 100 ASA, 24 EXPOSURE
 SUBJECT: VIEW OF DRUMS STACKED THREE HIGH IN BAY AREAS WEST OF LOADING DOCK.

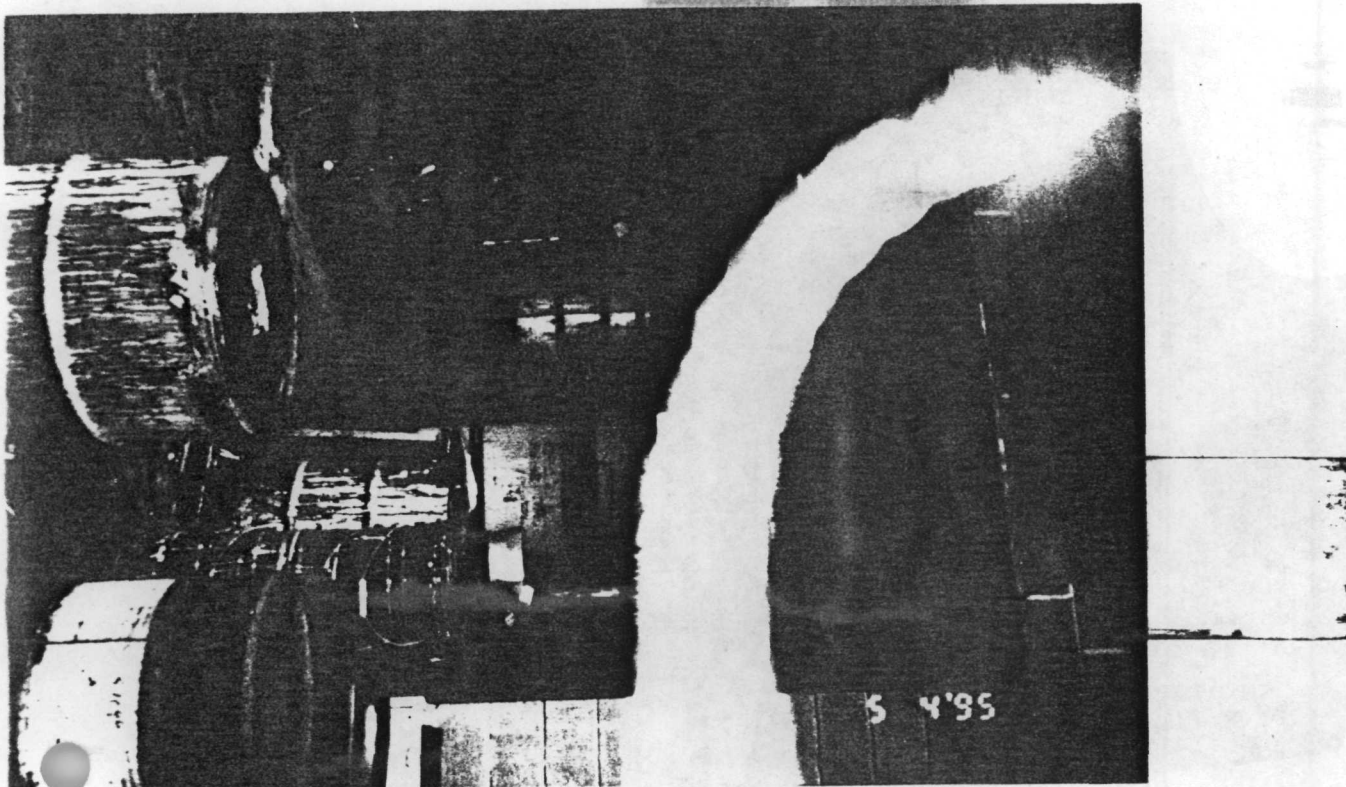
CAMERA: FUJI DISCOVERY PLUS 80
 FILM: KODAK GOLD 100 ASA, 24 EXPOSURE
 SUBJECT: VIEW OF ABANDONED DRUMS AND TANKS IN BAY AREAS.

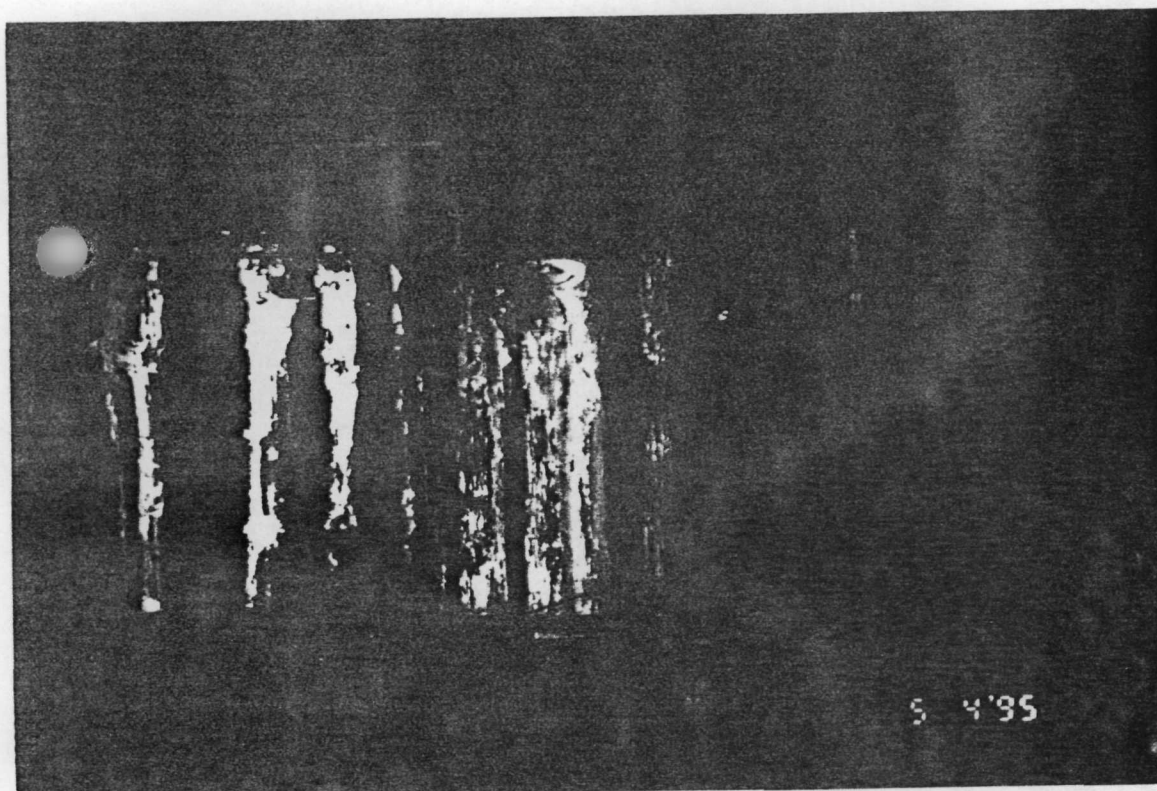
CAMERA: FUJI DISCOVERY PLUS 80
 FILM: KODAK GOLD 100 ASA, 24 EXPOSURE
 SUBJECT: VIEW OF DRUMS AND TANKS IN BAY AREAS WEST OF LOADING DOCK.

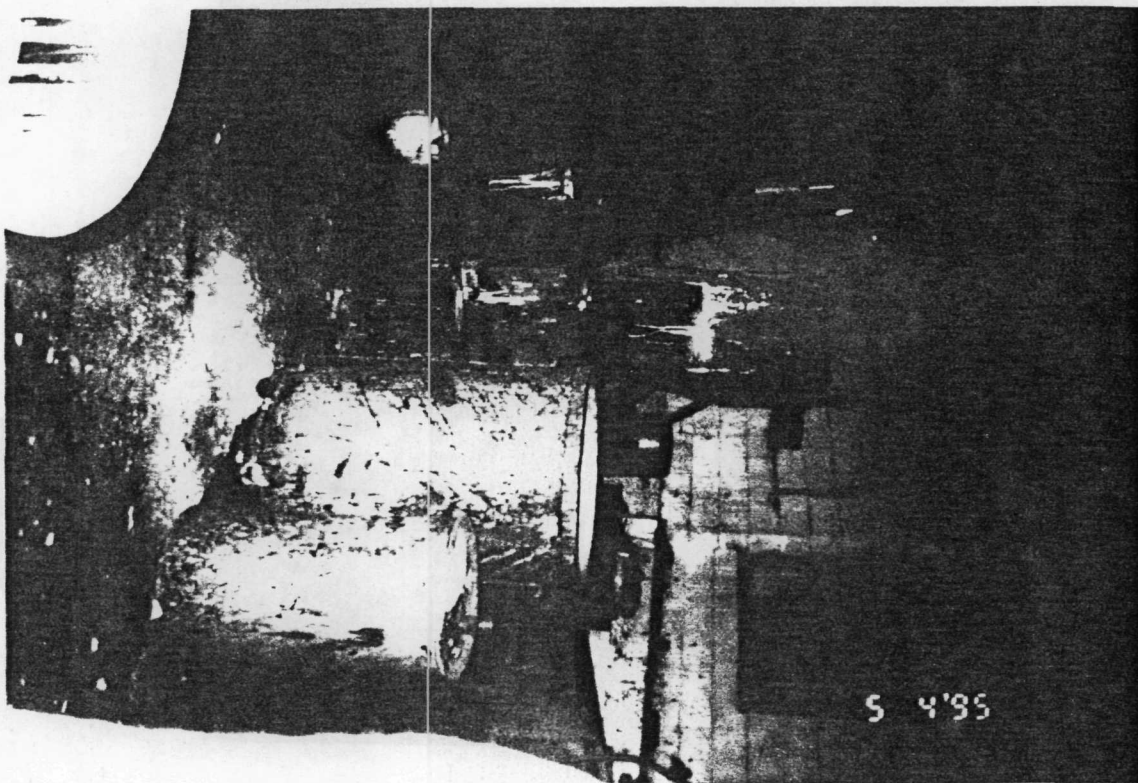
CAMERA: FUJI DISCOVERY PLUS 80
 FILM: KODAK GOLD 100 ASA, 24 EXPOSURE
 SUBJECT: VIEW OF LEAKING TANK AND MISCELLANEOUS CONTAINERS.

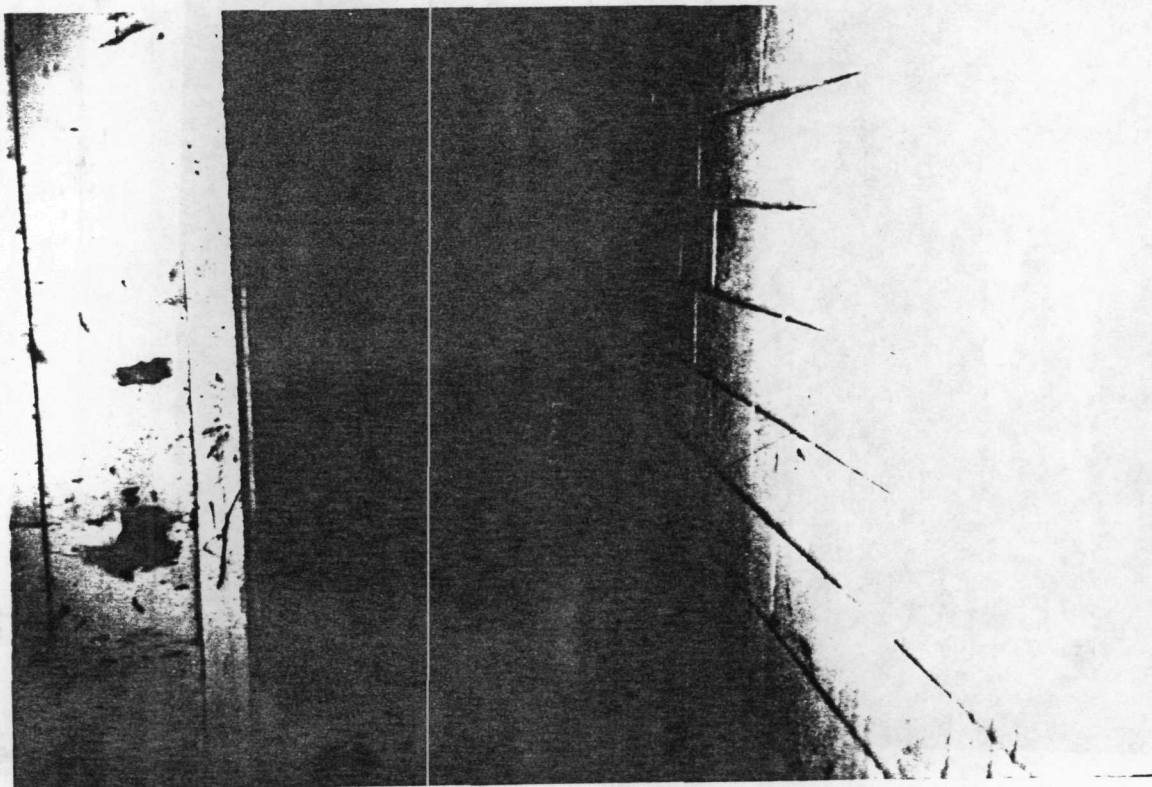
CAMERA: FUJI DISCOVERY PLUS 80
 FILM: KODAK GOLD 100 ASA, 24 EXPOSURE
 SUBJECT: VIEW OF ABANDONED CONTAINERS.

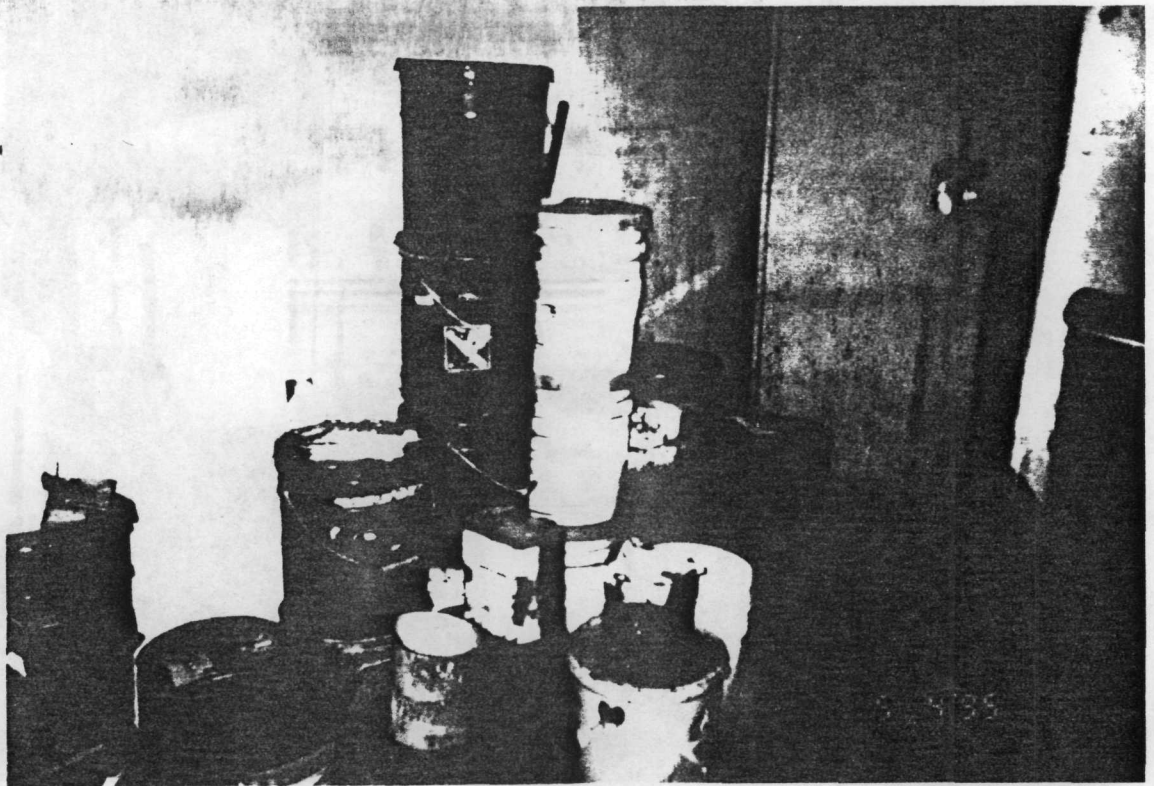
CAMERA: FUJI DISCOVERY PLUS 80
 FILM: KODAK GOLD 100 ASA, 24 EXPOSURE
 SUBJECT: VIEW OF STACKED CONTAINERS OF FLAMMABLE LIQUID

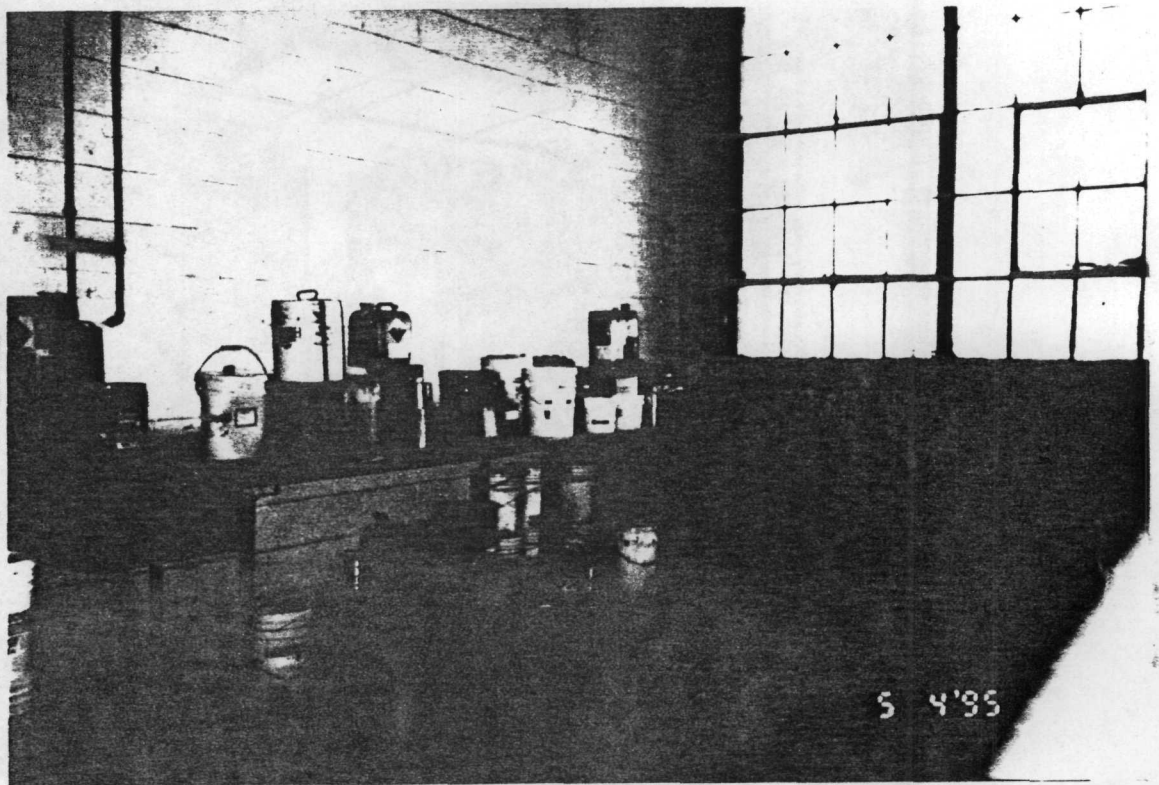
CAMERA: FUJI DISCOVERY PLUS 80
 FILM: KODAK GOLD 100 ASA, 24 EXPOSURE
 SUBJECT: VIEW OF ABANDONED CONTAINERS SOUTH OF LAB AREA

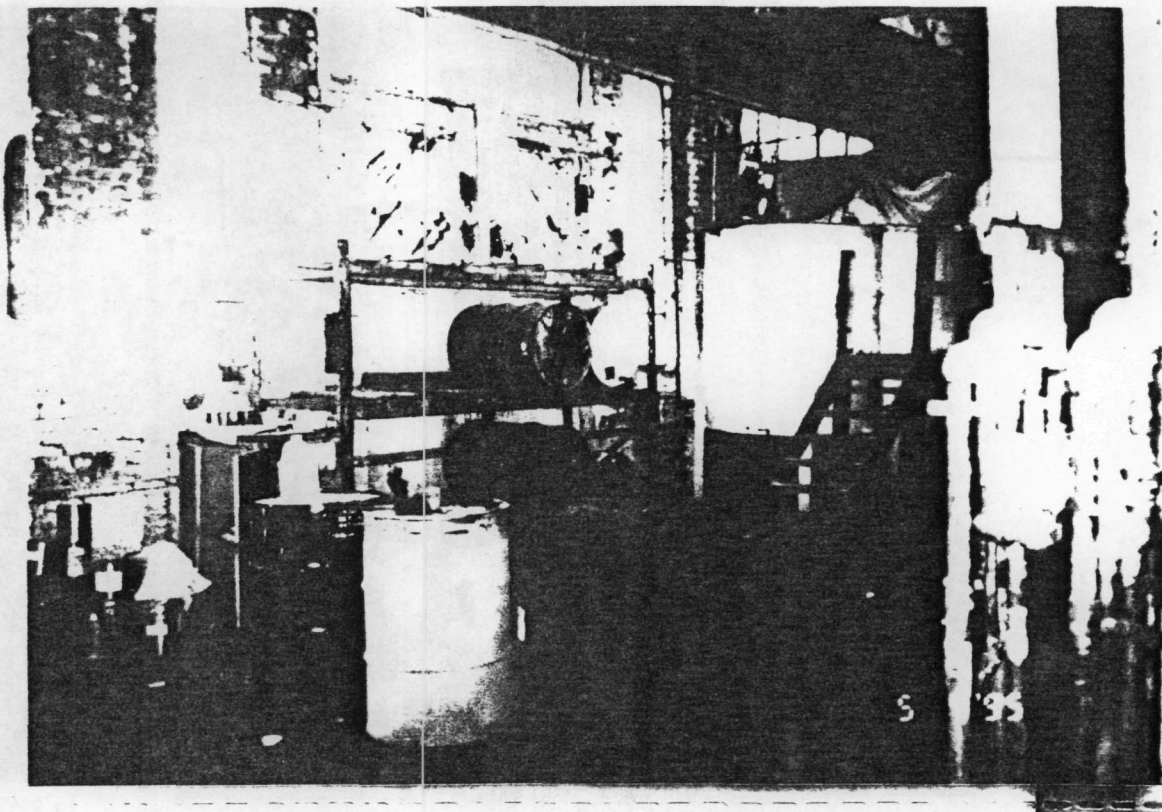
CAMERA: FUJI DISCOVERY PLUS 80
 FILM: KODAK GOLD 100 ASA, 24 EXPOSURE
 SUBJECT: VIEW OF DRUMS AND TANKS IN FACILITY.

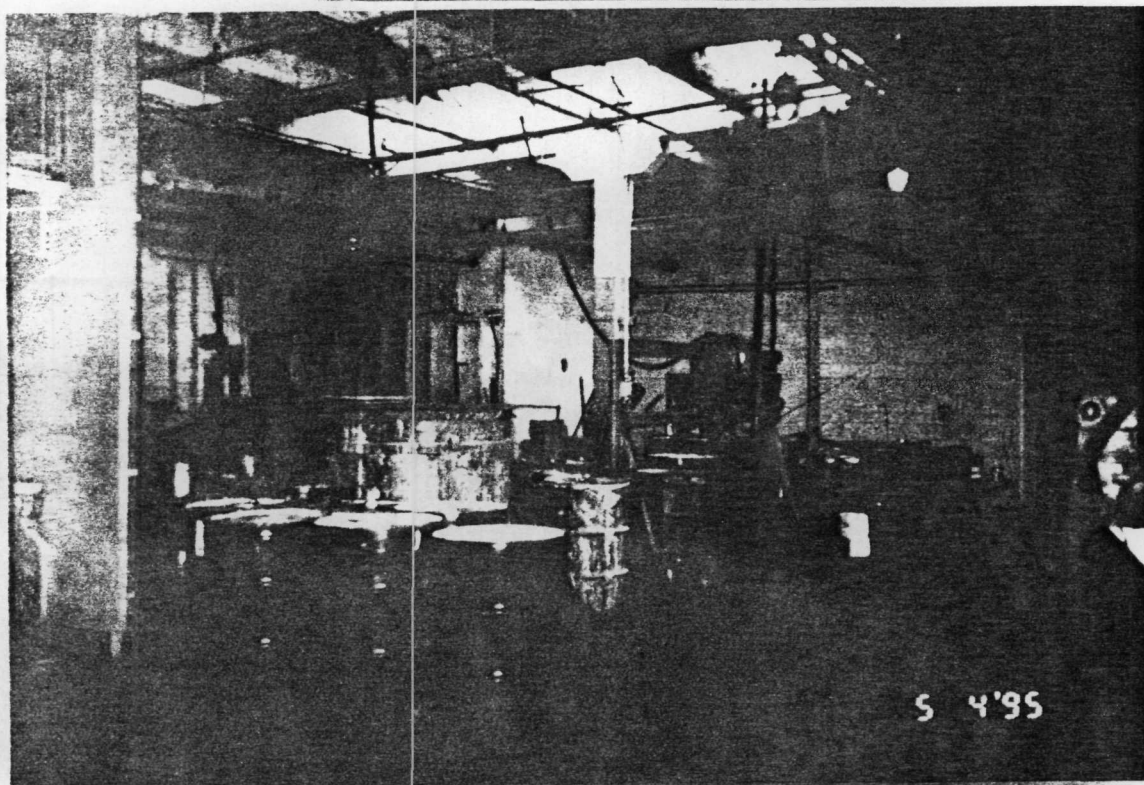
CAMERA: FUJI DISCOVERY PLUS 80
 FILM: KODAK GOLD 100 ASA, 24 EXPOSURE
 SUBJECT: VIEW OF ABANDONED DRUMS WITHIN FACILITY BUILDING.

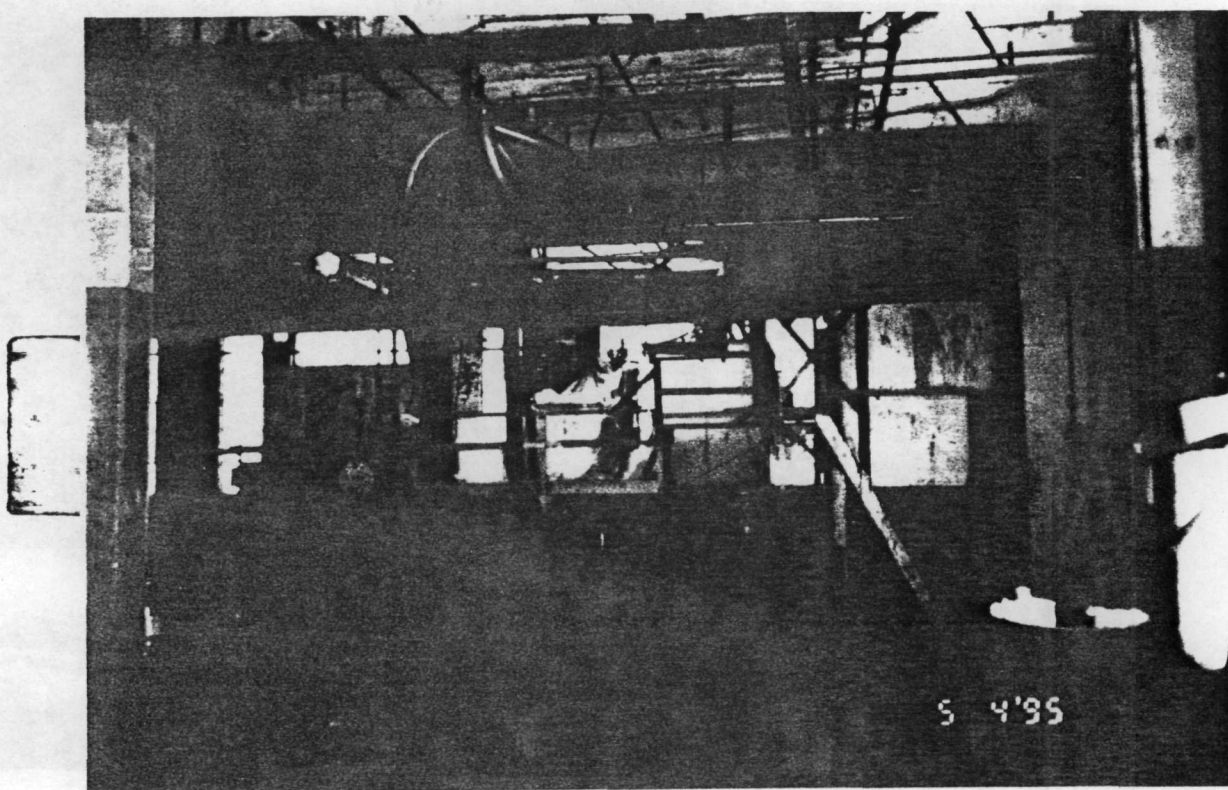
CAMERA: FUJI DISCOVERY PLUS 80
 FILM: KODAK GOLD 100 ASA, 24 EXPOSURE
 SUBJECT: VIEW OF PLATFORM HOLDING TANKS OF FLAMMABLE MATERIALS.

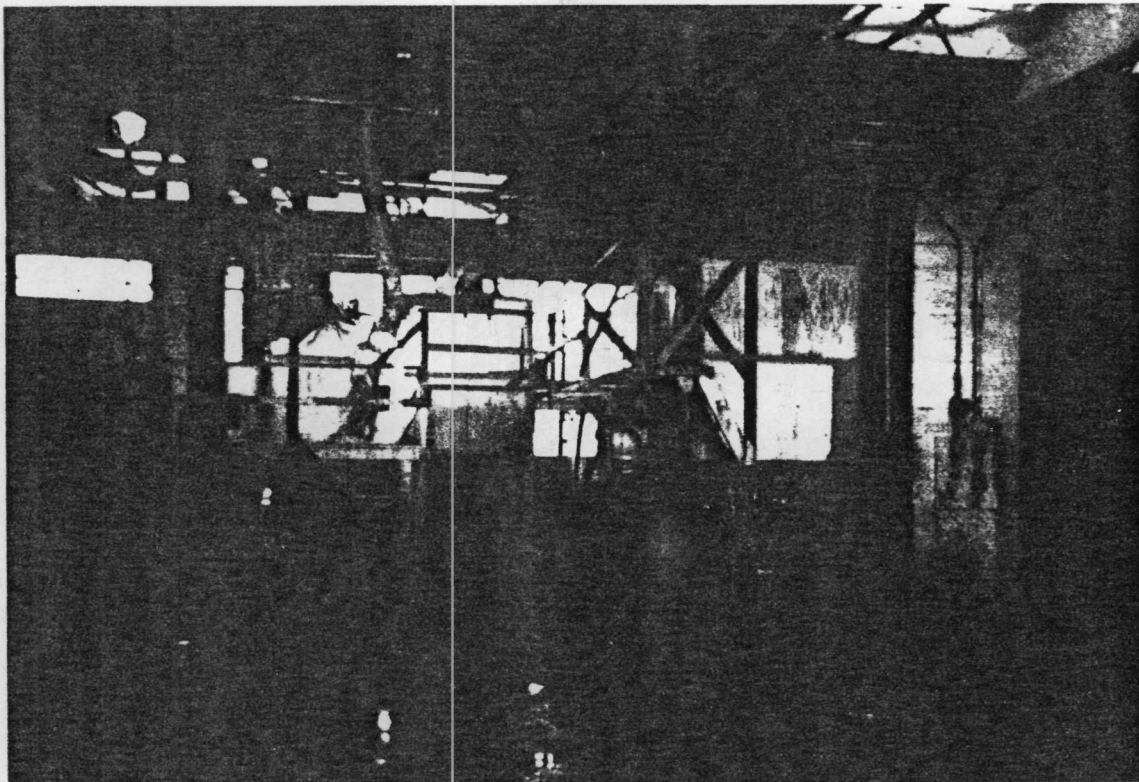
CAMERA: FUJI DISCOVERY PLUS 80
 FILM: KODAK GOLD 100 ASA, 24 EXPOSURE
 SUBJECT: VIEW OF TANKS ON A PLATFORM.

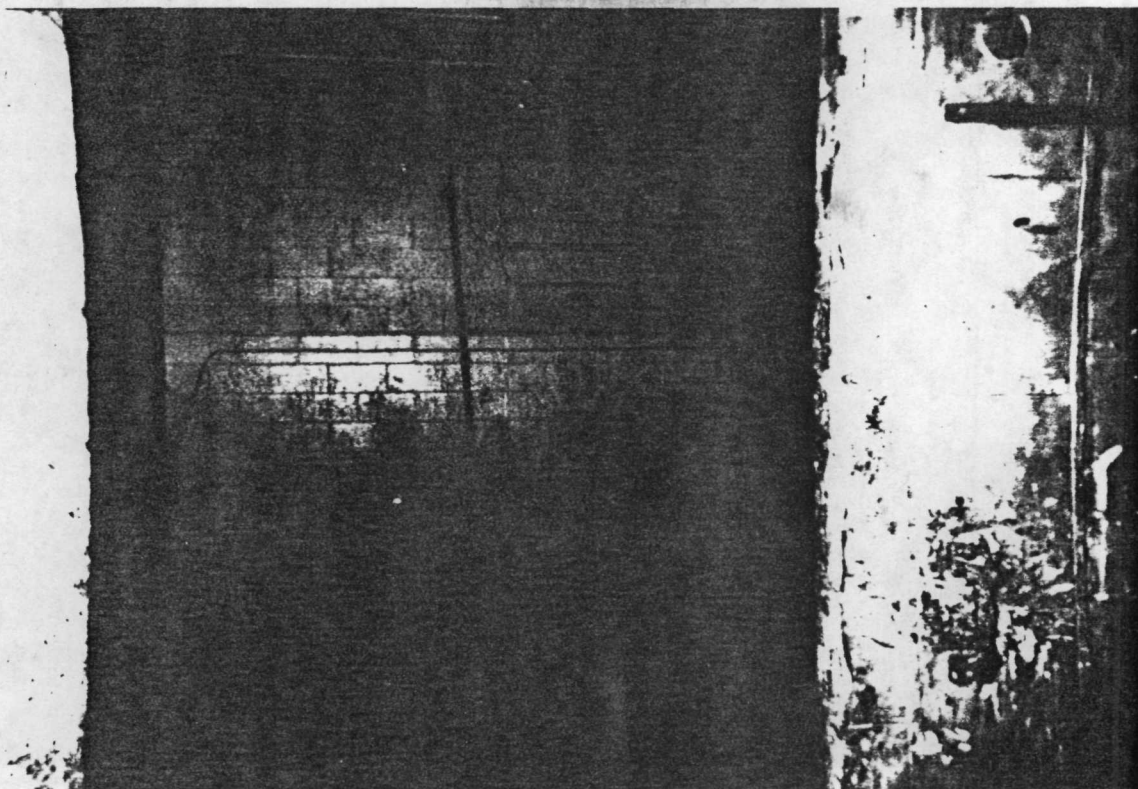
CAMERA: FUJI DISCOVERY PLUS 80
 FILM: KODAK GOLD 100 ASA, 24 EXPOSURE
 SUBJECT: VIEW OF DRUMS IN STORAGE ROOM.

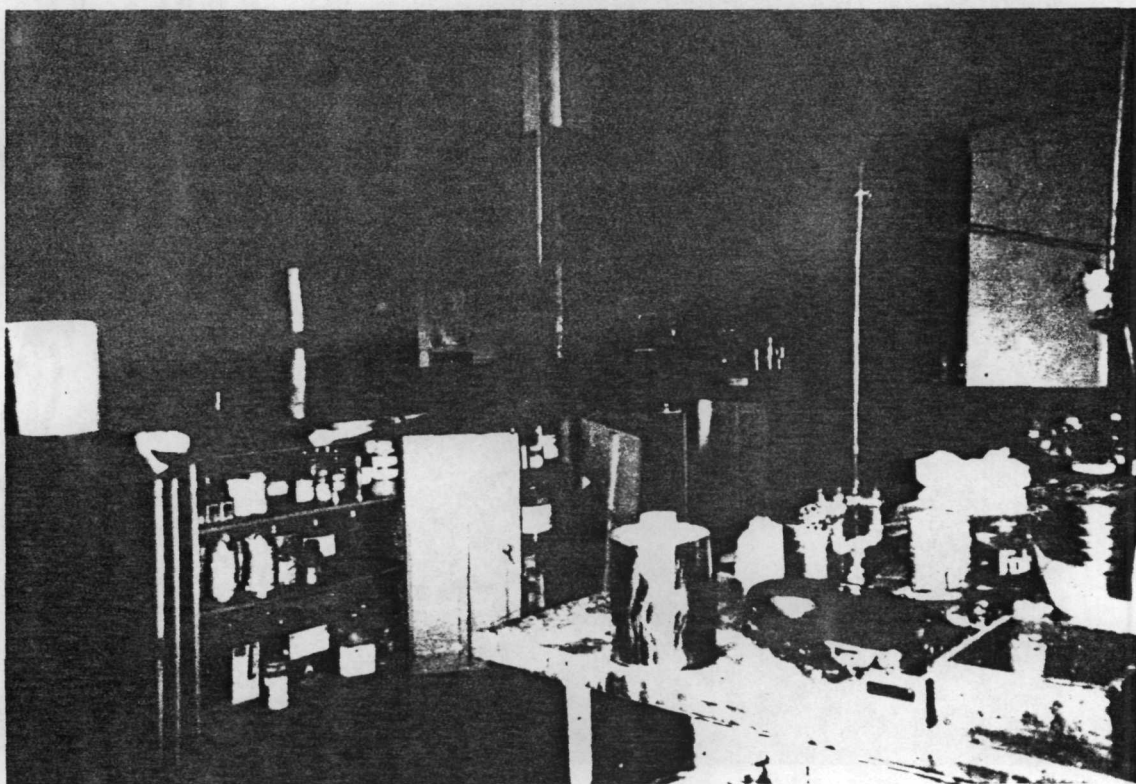
CAMERA: FUJI DISCOVERY PLUS 80
 FILM: KODAK GOLD 100 ASA, 24 EXPOSURE
 SUBJECT: VIEW OF NUMEROUS CONTAINERS IN LAB AREA.

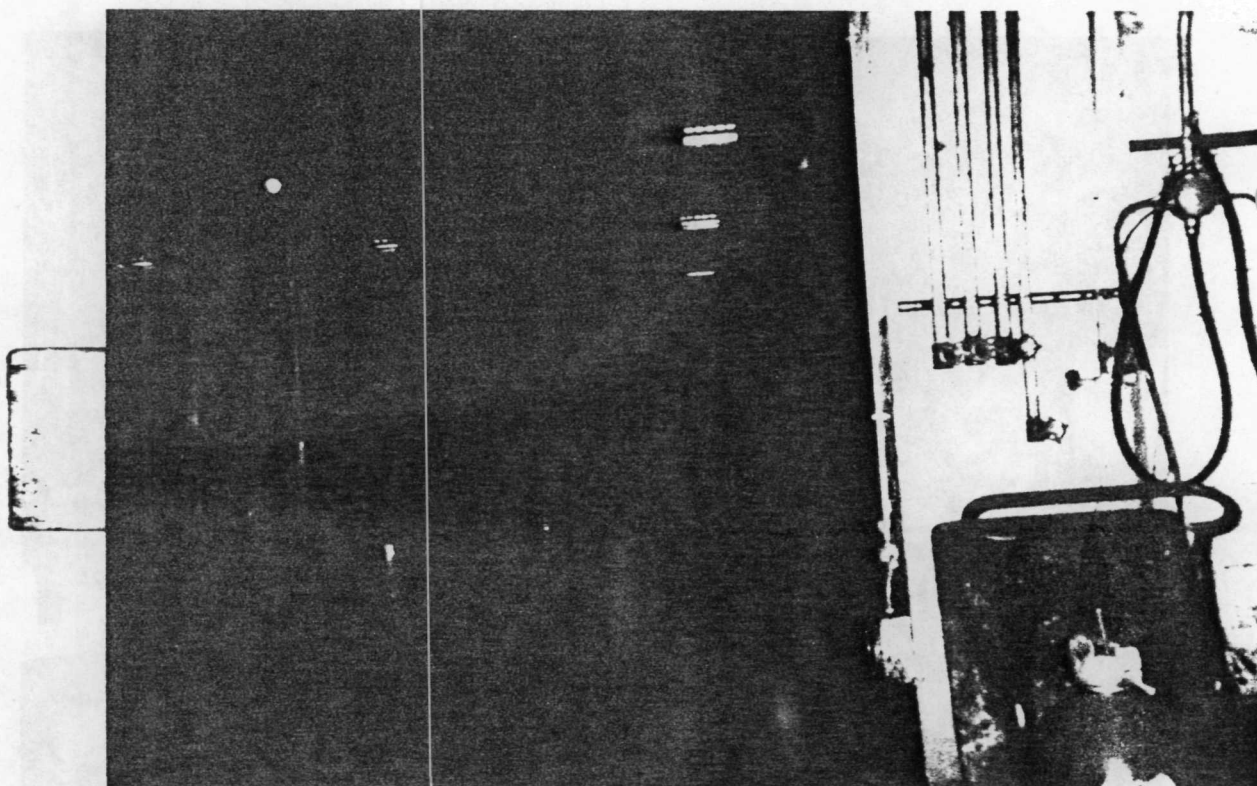
CAMERA: FUJI DISCOVERY PLUS 80
 FILM: KODAK GOLD.100 ASA, 24 EXPOSURE
 SUBJECT: VIEW OF DRUMS IN STORAGE ROOM.

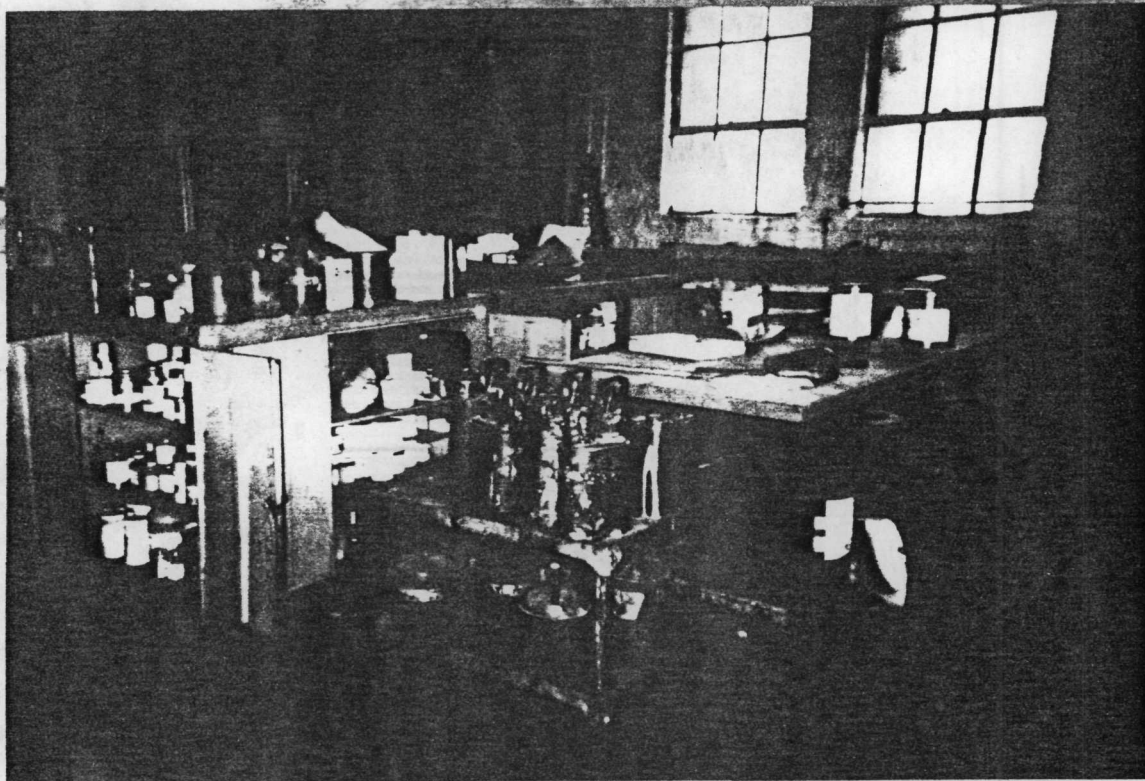
CAMERA: FUJI DISCOVERY PLUS 80
 FILM: KODAK GOLD 100 ASA, 24 EXPOSURE
 SUBJECT: VIEW OF NUMEROUS CONTAINERS IN LAB AREA.

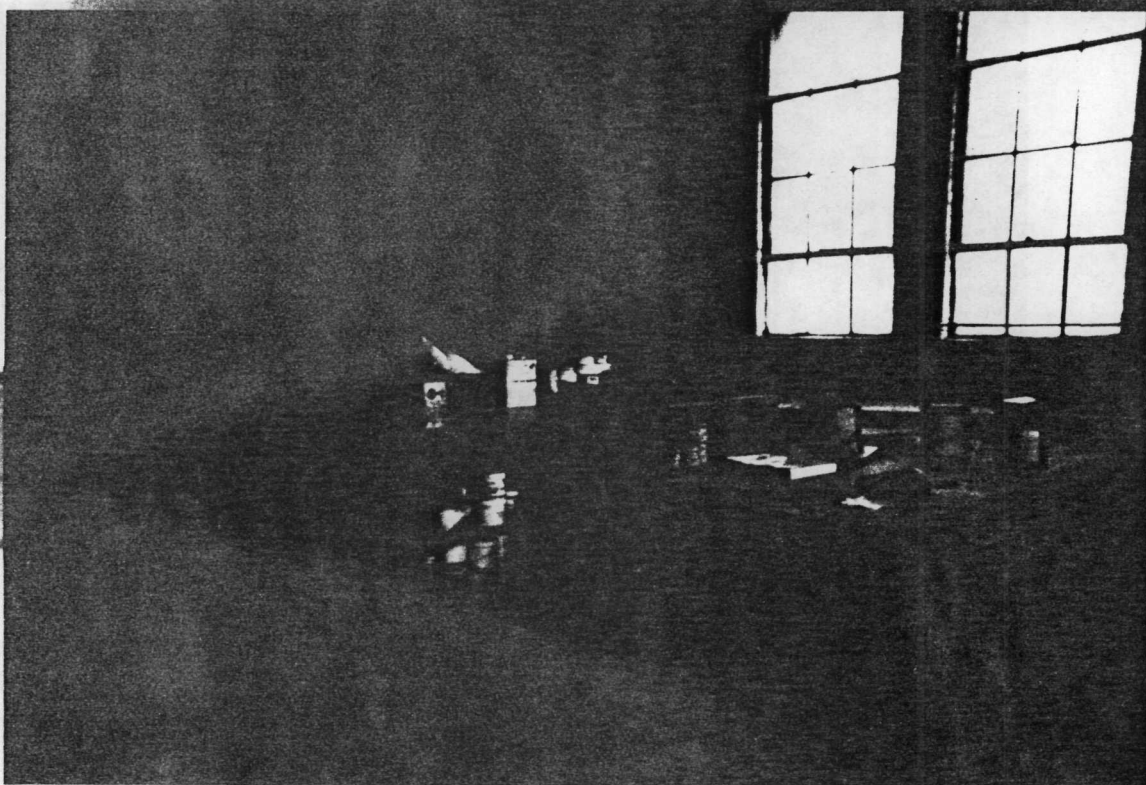
CAMERA: FUJI DISCOVERY PLUS 80
 FILM: KODAK GOLD 100 ASA, 24 EXPOSURE
 SUBJECT: VIEW OF NUMEROUS CONTAINERS IN LAB AREA.

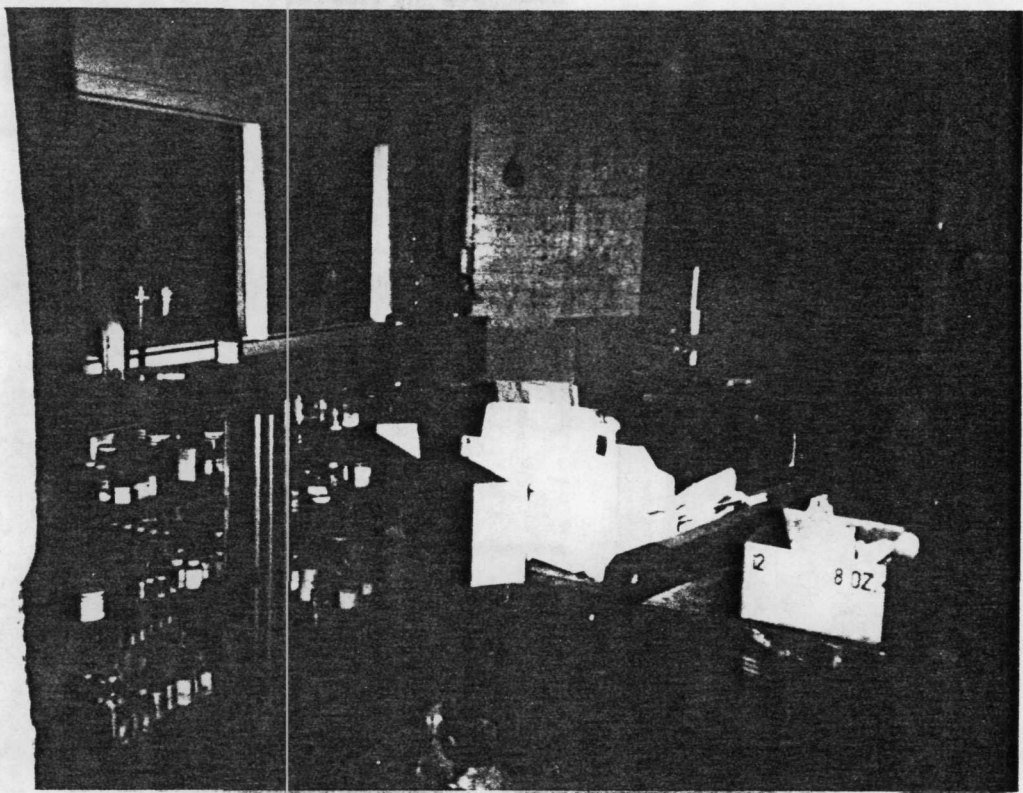
CAMERA: FUJI DISCOVERY PLUS 80
 FILM: KODAK GOLD 100 ASA, 24 EXPOSURE
 SUBJECT: VIEW OF CONTAINERS IN LAB AREA.

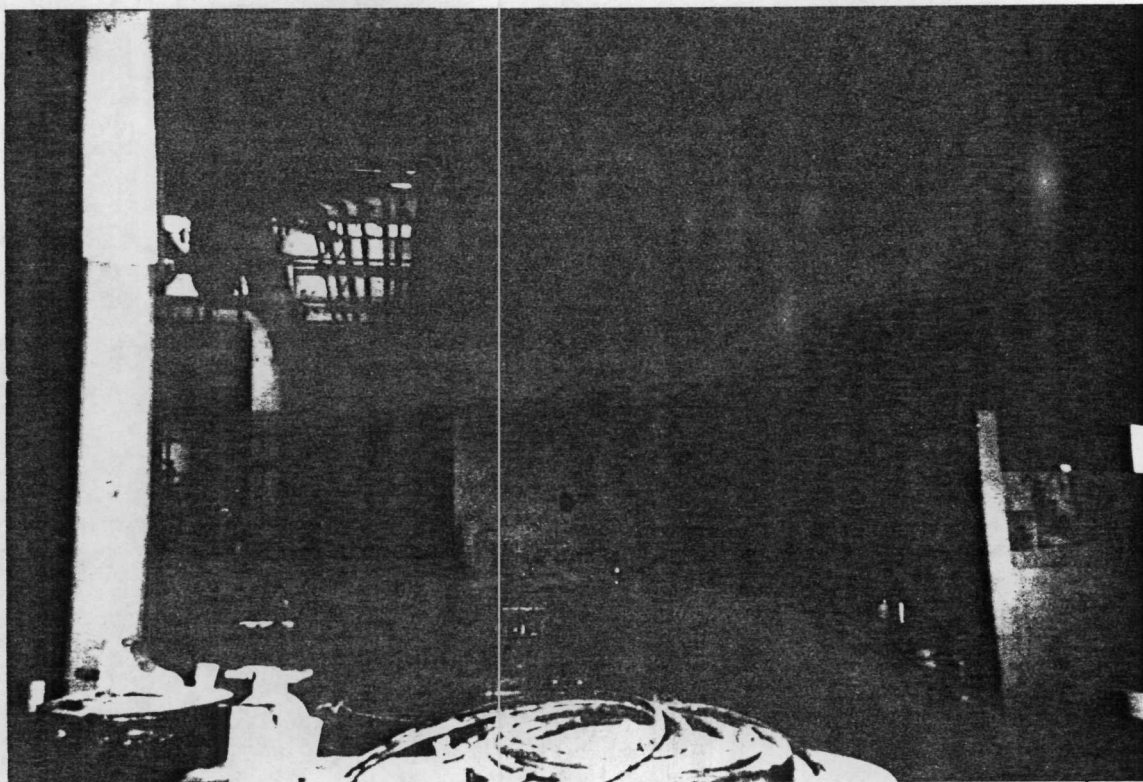
CAMERA: FUJI DISCOVERY PLUS 80
 FILM: KODAK GOLD 100 ASA, 24 EXPOSURE
 SUBJECT: VIEW OF DRUMS IN FACILITY.

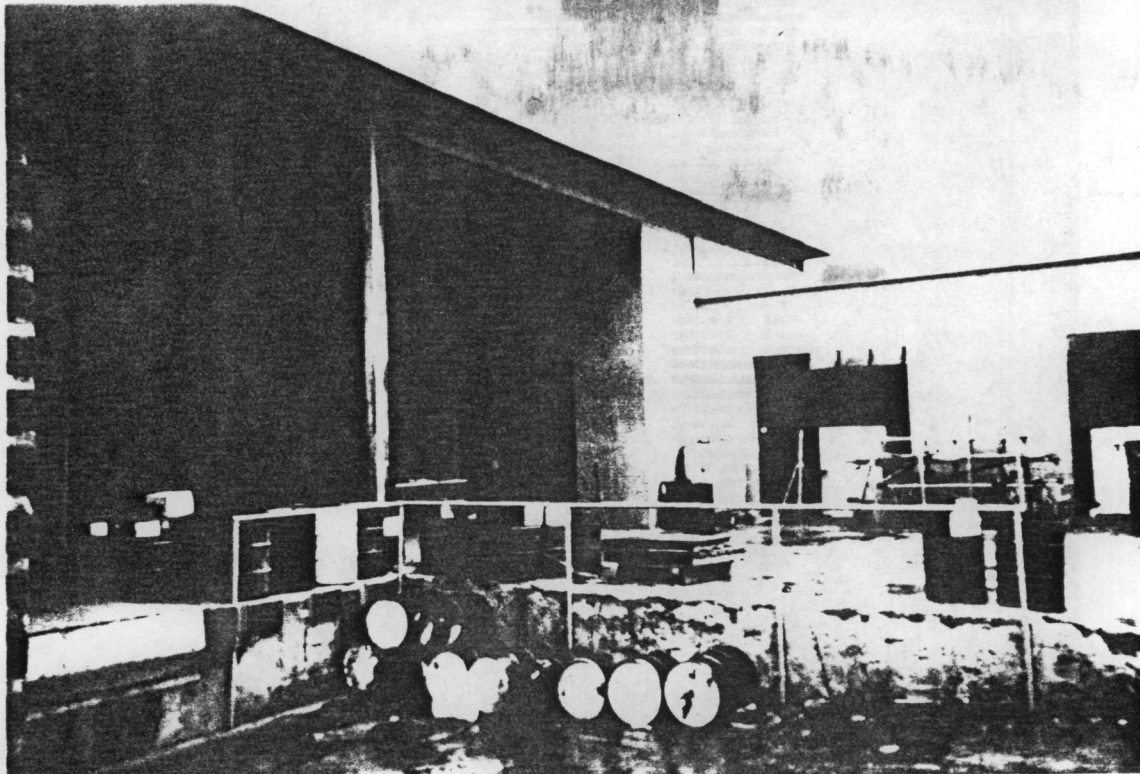
CAMERA: FUJI DISCOVERY PLUS 80
 FILM: KODAK GOLD 100 ASA, 24 EXPOSURE
 SUBJECT: VIEW OF ABANDONED DRUMS IN DOCK AREA.

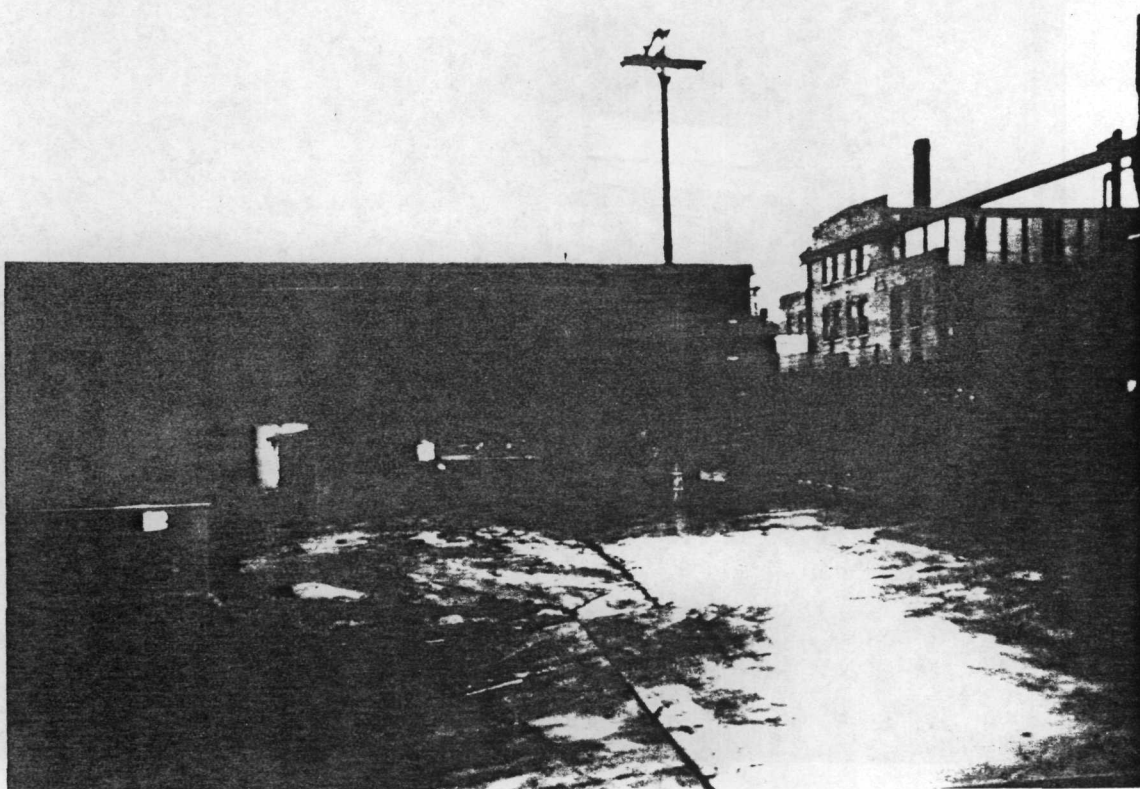
CAMERA: FUJI DISCOVERY PLUS 80
 FILM: KODAK GOLD 100 ASA, 24 EXPOSURE
 SUBJECT: VIEW OF BAY AREAS WEST OF LOADING DOCK.

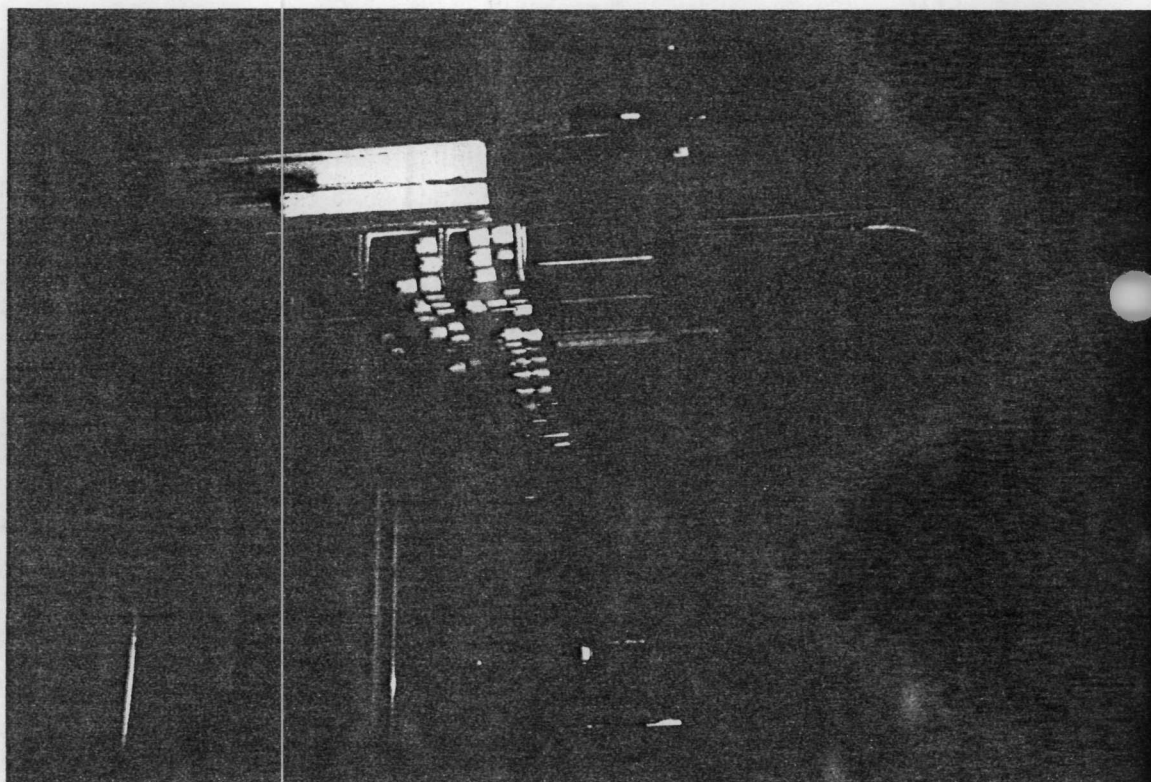
CAMERA: FUJI DISCOVERY PLUS 80
 FILM: KODAK GOLD 100 ASA, 24 EXPOSURE
 SUBJECT: VIEW OF CONTAINERS WEST OF LAB AREA.
